## Filter Diaphragms

**Course Number:** CE-02-209

# Filter Diaphragms

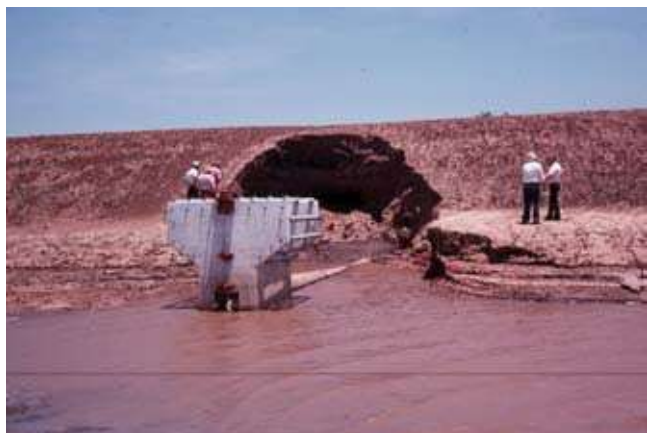
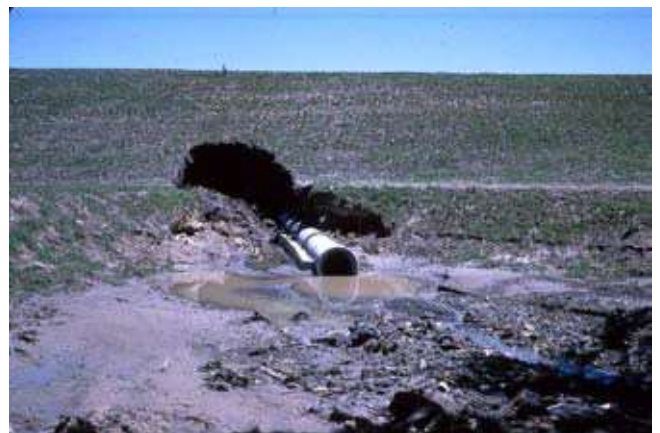
**Figure 45-1** Failed embankments

- Studies of the failed embankments showed that the pathway for the water that eroded a tunnel through the dam was most often not directly along the contact between the conduit and backfill, but it was in the earthfill above or to either side of the conduit.
